**RIVERBED DEFORMATIONS IN THE UPPER DNISTER CATCHMENT
UNDER GRAVEL-PITS EXPLOITATION**

Andriy Mykhnovych, Olha Pylypovych
Ivan Franko National University of Lviv, Ukraine

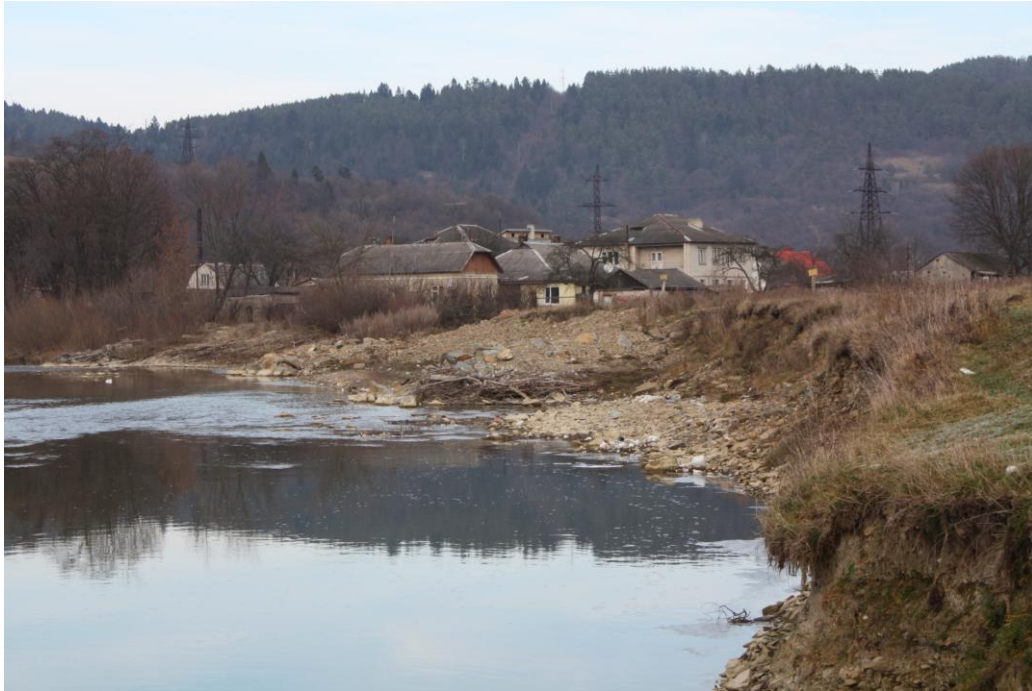
Figure 1. Horizontal riverbed deformations on the Dnister River due to the gravel-pebble withdrawal downstream of the river

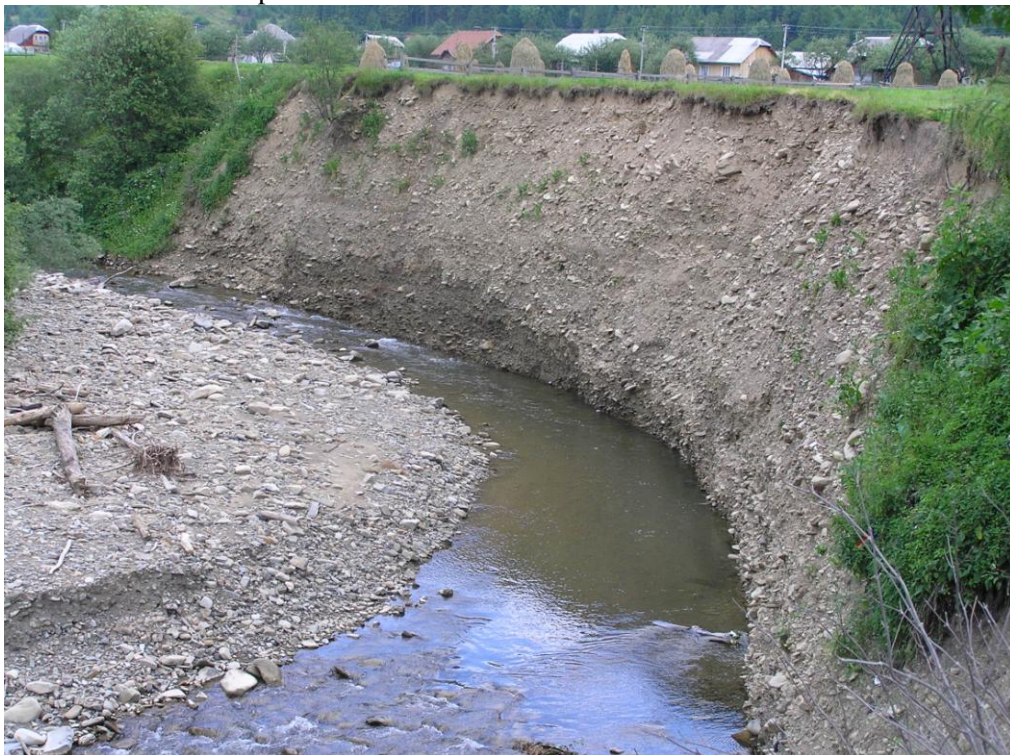
Figure 2. Intensive vertical deformations in the Butyvlia riverbed as a result of gravel-pebble withdrawal downstream in the Oriava River

Voloshynove, Saryi Sambir	Yablun'ka	Village road, private economies	Gravel-pebble withdrawal Vertical and horizontal deformations
Korostiv	Oriava, Butyvlia		Intensive Vertical and horizontal deformations (Figure 2)
Krushelnytsia	Stryi	Private economies	Riverbed bifurcation, bank erosion
Verkhnie Syniovydne	Opir	The bridge	Intensive gravel-pebble material withdrawal in the riverbed under the bridge

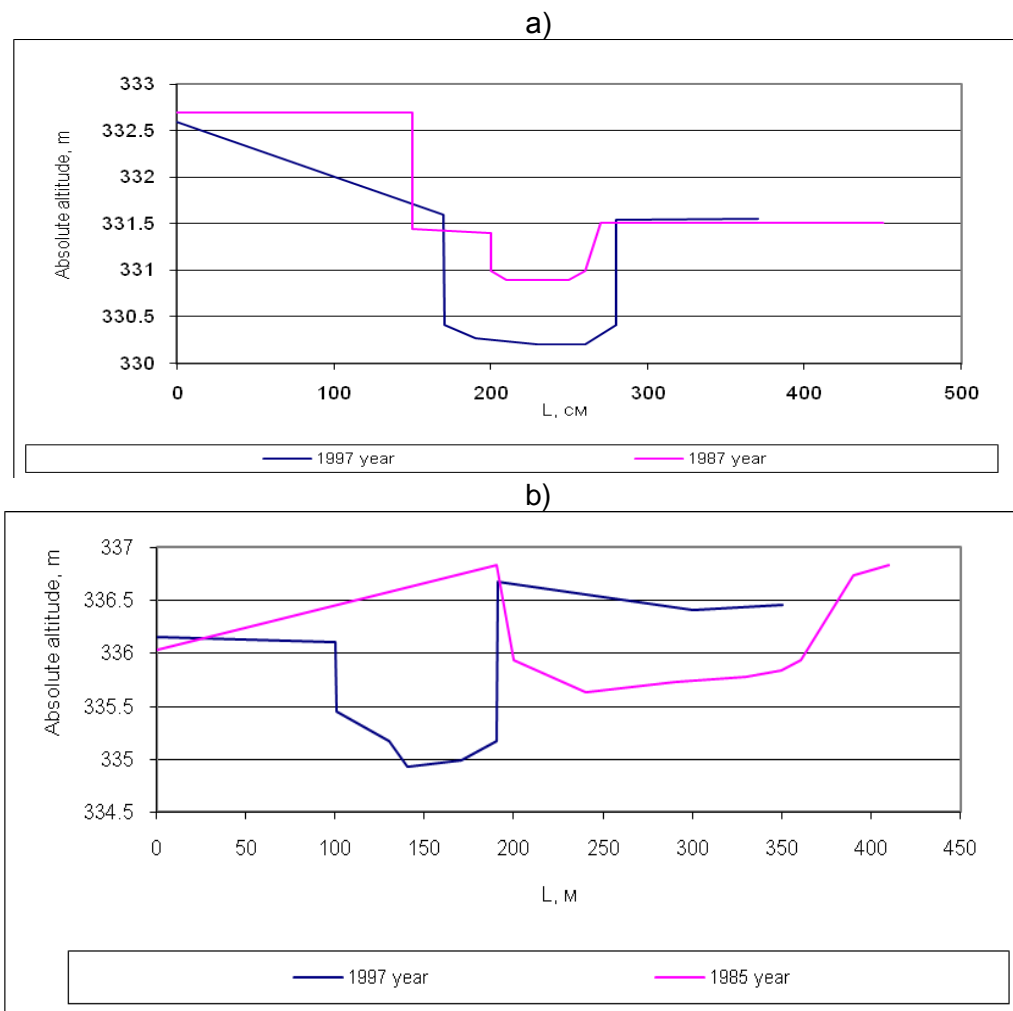
Figure 3. Changes of the cross-sections of the Yablun'ka riverbed for the period 1985 – 1997 at a distance of a) 21 m from the mouth; b) 420 m from the mouth

The riverbed stability index is the parameter which characterizes the self regulation processes velocity in river channel. Concerning the Yablun'ka River this index has been calculated at the first time by the method proposed by M. Velikanov: $y = d*(h*I)-I$, where y – riverbed stability index, d – average diameter of the sediments, h – river flow depth, I – riverbed inclination. According to the calculations the index changed between 0,65 in 1987 to 2,2 in 1997. 3,8 times increasing testifies about rapid activization of the riverbed processes. For example the investigations of K. Berkovich and L. Zlotina have shown the same riverbed stability index for the Dnister River between Bendery and Dubosary towns. Due to the alluvium withdrawal which exceeds the riverbed-forming suspended load runoff the stability index has increased 5 times for three years [1, 2]. The stable riverbed is characterized by the stability index $y = 15$. In 2005 in the Yablun'ka riverbed on the distance 1 km from the mouth 7 gabions have been constructed against intensive vertical deformations.

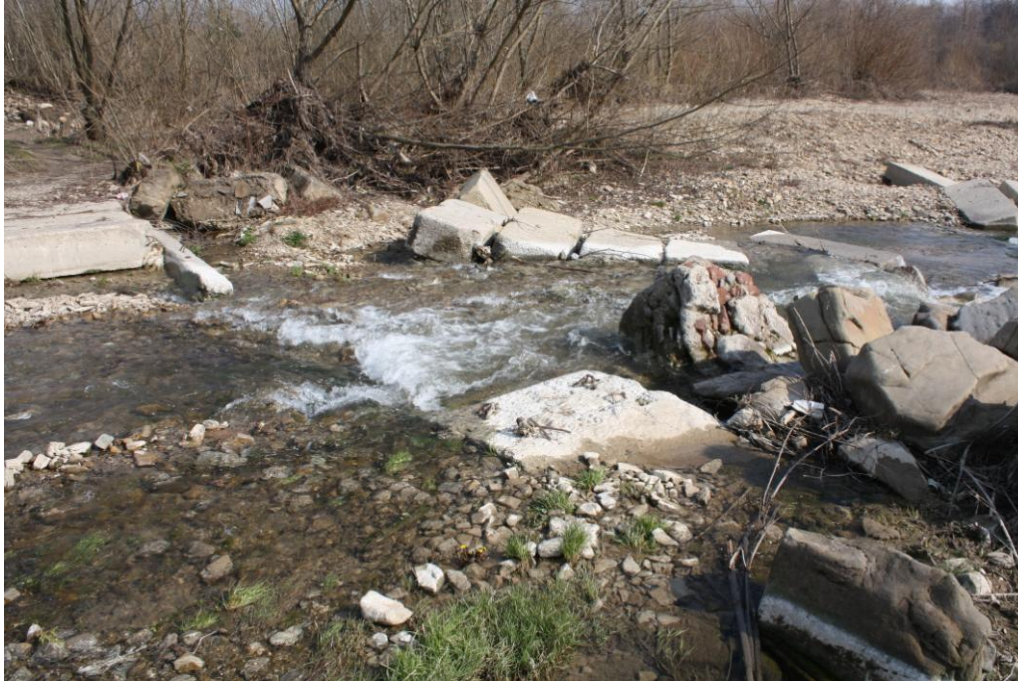
Figure 4. Destroyed gabions because of intensive vertical deformation of the riverbed (March 2016)

According to our observations such measures solved the problem partly and temporary only. All gabions have been destroyed by the stream flow and vertical deformations are very intensive again. This conclusion is confirmed by the field investigations in March 2016 (Figure 4).
