THE MODERN MORPHODYNAMICS IN THE QUARRIES OF LVIV AND ITS SUBURBS

Pavlo Horishnyj, Mariia Halaiko

Ivan Franko National University of Lviv,

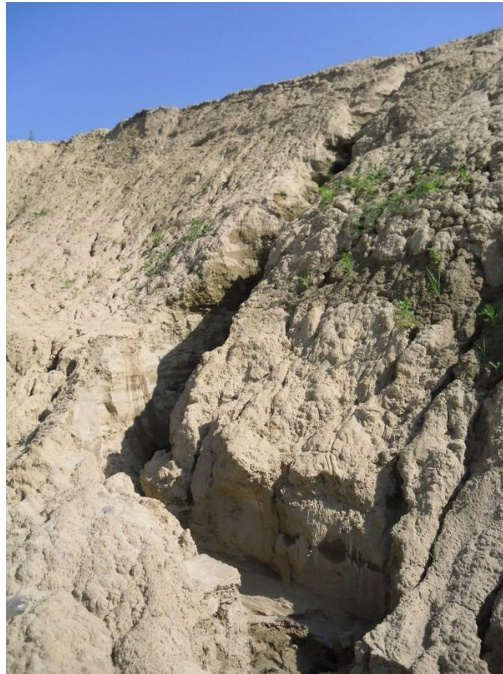
Fig. 1. A small gully with an irregular longitudinal profile (the Davydivskiy Quarry № 2)

On the slope of dump of the southwestern exposition there is a small gully in the heaped sediments. Its length is 15–20 m. It has a stepped longitudinal profile and flat pit floor. The upper part has considerable steepness, sometimes reaching an upright position. Width is 40–60 cm (maximum 90 cm), depth 70 cm. On the slope of gully, we can see the stratification of heaped sediments, which are represented by sand (Fig. 1).

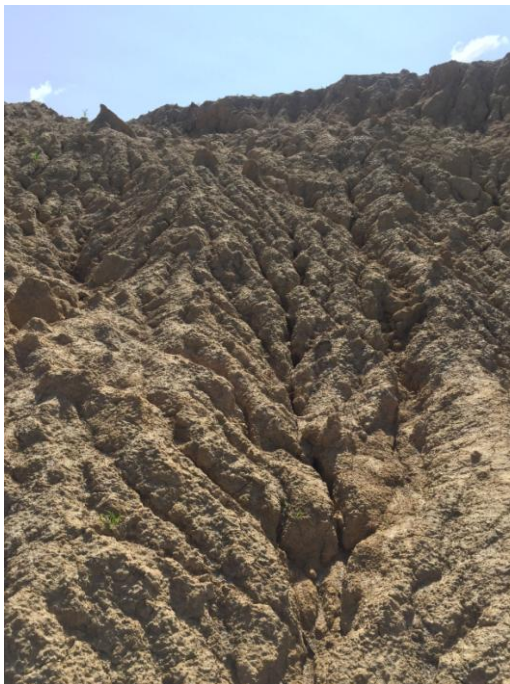
Fig. 2. Pre-rill erosion (the Davydivskiy Quarry № 3)

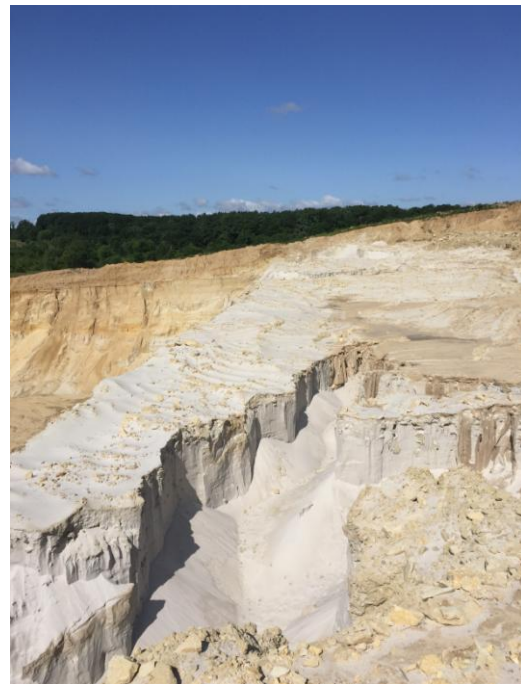
Fig. 3. A small gully in sand deposits (the Davydivskiy Quarry № 3)

On the berm surface, in the sandy deposits, there is a small gully with lateral branches (Fig. 3). Its mouth goes to the quarry wall. It extends in parallel to the bench. The length of main gully is 15 m, the depth is 2 m. The upper wall is upright, the lower one is a scree (corresponds to the angle of free fall). The width between the crowns is 2–3 m. The gully narrows to the top. The activity of process is explained by the lack of a protective effect of vegetation.

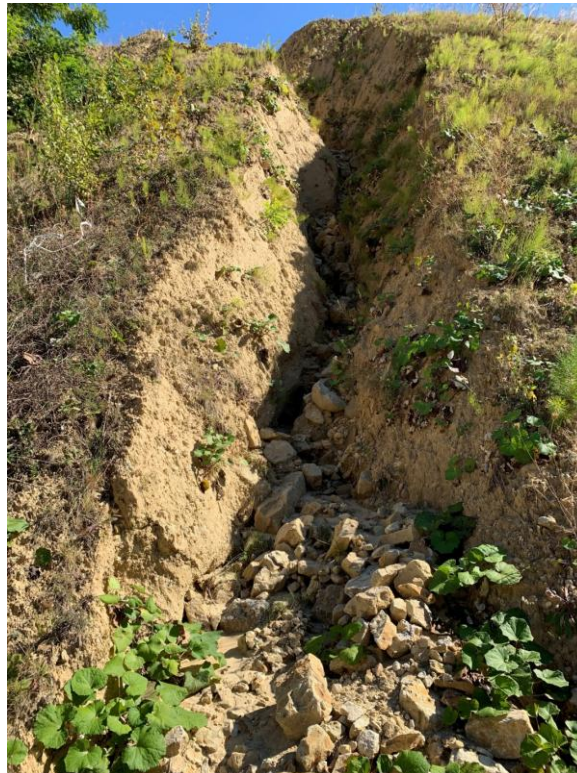
Fig. 4. The lower part of gully and the debris cone on the slope of dump (the Vynnychkivskiy Quarry)

The gully is located on the dump slope of southern exposition. Its debris cone is composed mainly of coarse sediments (up to 35 cm in diameter), as well as loam and

sand (Fig. 4). The width of the cone is 2.5 m, the length is 3.3 m. The shape of the cross profile is V-shaped, the longitudinal profile is unevenly stepped. The sides of gully are not covered with vegetation. The average width of pit floor at the lower part is 52 cm, the depth of gully is 1–2.2 m. The width of pit floor at the upper part is 70–75 cm, and the depth reaches 3 m. The upper part changes the direction of extension. There are differences in heights in the pit floor. The erosive pre-rills are located on the left side of gully. The angle of incidence of the sides is more than 50° . There is a change in the direction of extension of the stream bed from 220° to 250° .

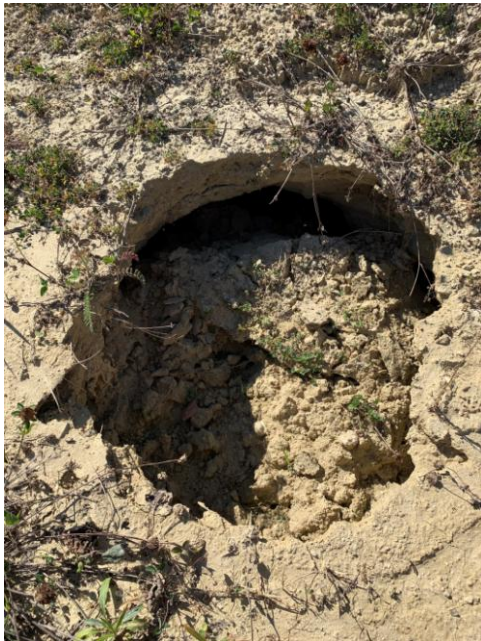
Fig. 5. Suffosion forms in heaped deposits (the Vynnychkivskyi Quarry)

represented by circular sinkholes (Fig. 5). One of the forms has a shape with diameter of 35 cm, the other has a size of 60 × 50 cm. The depth of both sinkholes ranges within 30 cm. The suffosion sinkholes and “wells” in the Davydivskyi Quarry, located at the

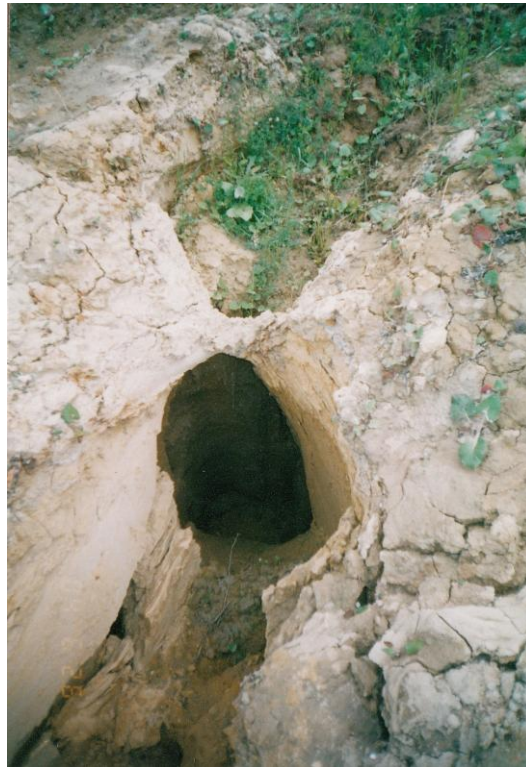
Fig. 6. Linear erosion with the formation of subsidence suffosion forms 2 – 3 m deep (the Davydivskyi Quarry № 2)

foot of dumps in loamy deposits, are explored in the mid-2000s. The suffosion processes develop in conjunction with rill and gully erosion processes (Fig. 6).

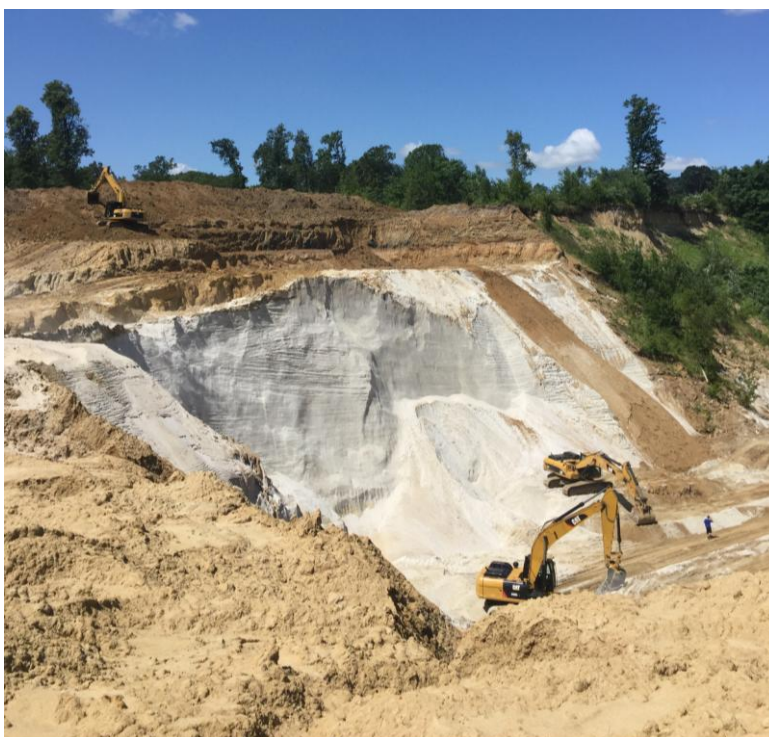
Fig. 7. Scree formation and water-erosion processes in the Davydivskyi Quarry № 1

Scree formation processes are well tracked on the southwestern wall of quarry (Fig. 7). The intensity of these processes on the working wall is probably increased after the excavation of sand. A formed vertical wall begins to crumble rapidly (fine-grained, layered, light gray sands). This is also facilitated by aeolian processes (Fig. 8). There are scree cones of different sizes. The scree cones are up to 8 m wide and up to 3–5 m high. The rock usually shattered from the top of wall.

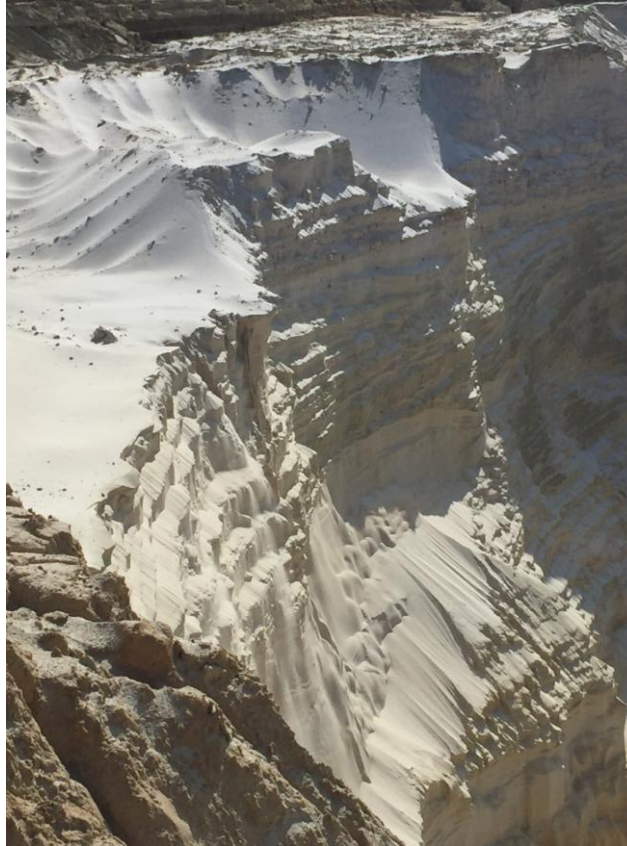
Fig. 8. The combination of scree formation and aeolian processes (the Davydivskiy Quarry № 1)

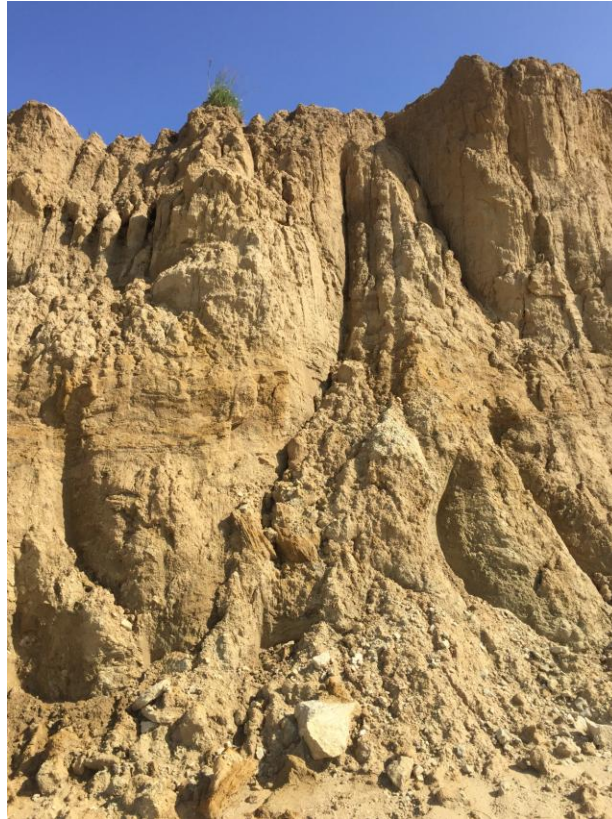
Fig. 9. Scree formation processes in the Davydivskyi Quarry № 3

The coarse sediments crumble and partially collapse on the wall of western exposition in the eastern part of quarry. Above the sands lies a bed of limestone, which due to mining operations, processes of water erosion and weathering, breaks away from the main mass of rocks and rolls down the slope, forming at the foot scree cones with coarse sediments. Scree formation also occurs on the southern wall (mainly loamy deposits of the overburden strata). The mixed deluvial-scree cones are formed there (Fig. 9).

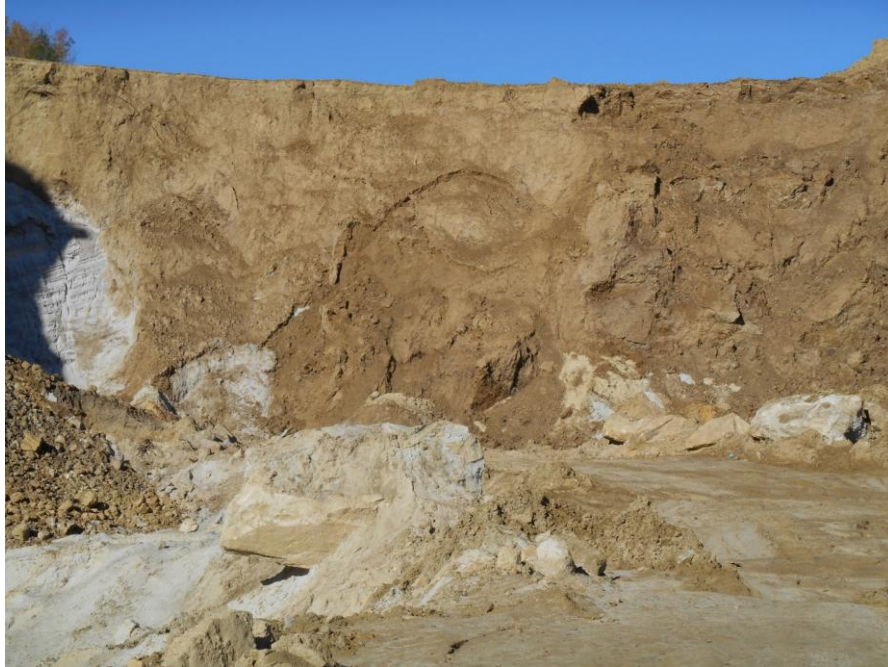
Fig. 10. Slides in heaped deposits of the Vynnychkivskiy Quarry

The slides' fault scarps of arched form are observed on the wall of southeastern exposition of *the Vynnychkivskyi Quarry* (mostly heaped) (Fig. 10). Above the crown, on the surface there are crown cracks, which fix the initial stage of slide processes. The height of fault scarp is 5–6 m. The capacity of individual blocks is up to 1.8 m. In the eastern part of quarry, there is a small slide on the wall of the northwestern exposition. Its length is 5 m, width 1.5 m.

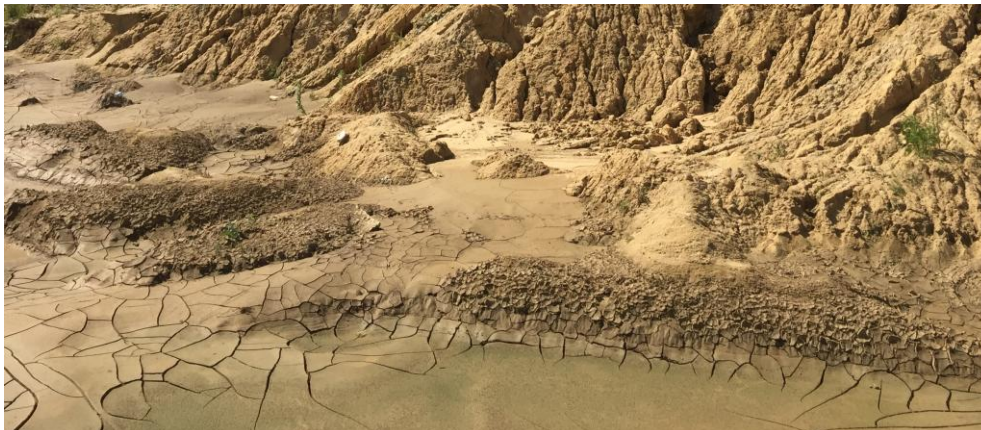
Fig. 11. The formation of a "desert papyrus" at the pit floor of the Davydivskyi Quarry № 3

Other processes. Interesting azonal processes are the formation of takyr surface and "desert papyrus". They are recorded in the Davydivskiy Quarry № 3 (Fig. 11) and Vynnychkivskiy Quarry. The process of "takyr formation" occurs on the closed flat watered areas of pit floors and leads to the formation of polygonal structure with a depth of cracks up to 12–15 cm after their drying and cracking. The final stage of the process is the twisting of the takyr surface into tubes (the formation of a "desert papyrus"). These processes were common in the Davydivskiy Quarry № 2 (northwest and east part of the quarry) during its exploitation.
