ANTHROPOGENIC INFLUENCE UPON THE SUKIL RIVER BED FUNCTIONING

Nazar Rybak¹, Lidia Dubis^{1,2}

Key words: channel morphodynamics; Sukil River; anthropogenic influence; mountain, premountain and plain parts of the basin.

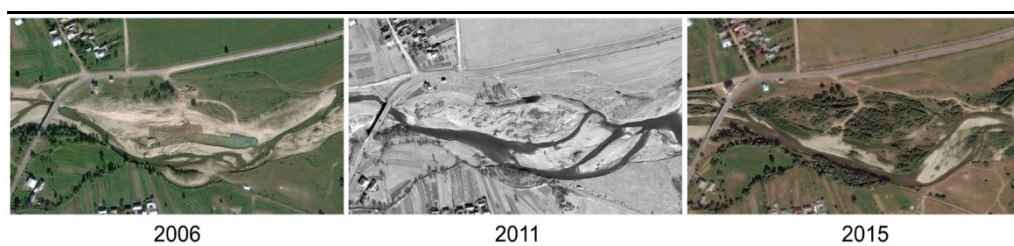
Fig. 5. Alluvium mining in the river shoal near Tysiv in 2006 (the mine area is 6 956 m²; the volume is more than 3 478 m³); the river bed type changes due to the alluvium mining in 2011; the natural river bed recovering in 2015

In 2011 the amount of gravel pits was 25. The locations were same as in 2006 but the most part of mining was concentrated between the settlements Bolekhiv and Lysovychi. The mining was done in the river bed shoals, had a spontaneous character and can be seen on the satellite images up to 2020. On the satellite images of the years 2015 and 2020 the accumulative forms renewing is observed. This renewing is caused by the intensive sediments transportation during the floods (Fig. 5).

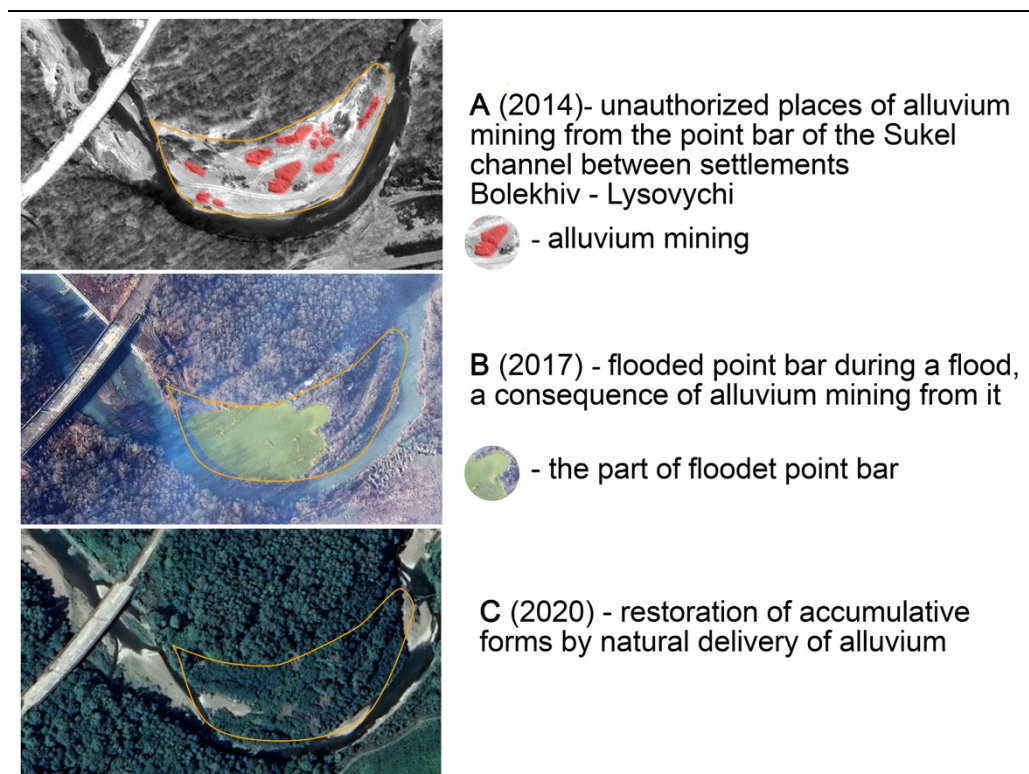
Fig. 6. Alluvium mining from the river bed shoals (A), mining impact on the water flow character during the flood (B), renewing of the natural state of the accumulative form (C)

Gravel mining from the river bed shoals and floodplain causes negative relief forms (Fig. 6A), which act during the floods like water rejecting reservoirs and make the flood

peak lower (Fig. 6B) (Rinaldi et al., 2005). At the same time, they accumulate also the sediments. These processes help to renew the natural state of the river bed (Fig. 6C) and cause erosion development downstream (Rinaldi et al., 2005; Calle et al., 2017; Mykhnovych & Pylypovych, 2017).

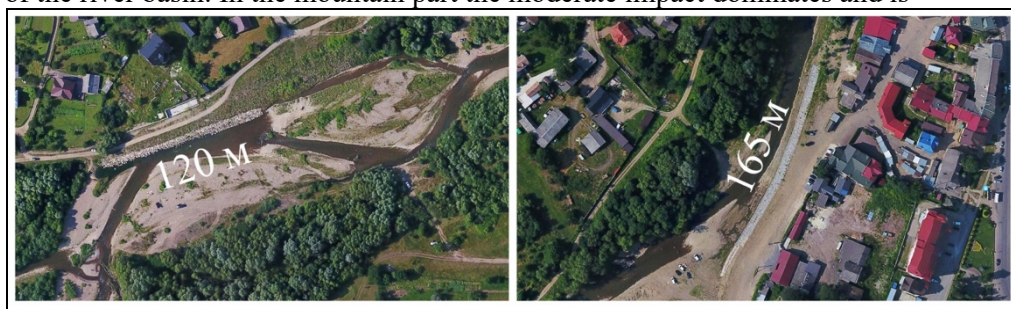
Fig. 8. Erosion-resistant constructions in Bolekhiv town

The extreme flood in the July 2008 has destroyed 2 anti-erosion constructions in Tysiv village and Bolekhiv town. The side erosion damaged the transport infrastructure and houses located there. It provides to build the bank reinforcing engineering like gabions. The constructions with the length of 120 m were built on the furcated river bed segment near Tysiv in 2011 and 2015 and near Bolekhiv town with the length of 120–165 m in 2019 and 2020 (Fig. 8).

In the places of gabions partly straightening river bed processes are observed. The gravel mining for gabions constructing caused the local regressive erosion cutting of the river bed.
