DETECTING CRACKS IN CONCRETE BASED ON IMAGES USING AMAZON WEB SERVICE REKOGNITION

The purpose of the work is to investigate the possibilities of using the AWS cloud environment with the Rekognition function to detect cracks in concrete.

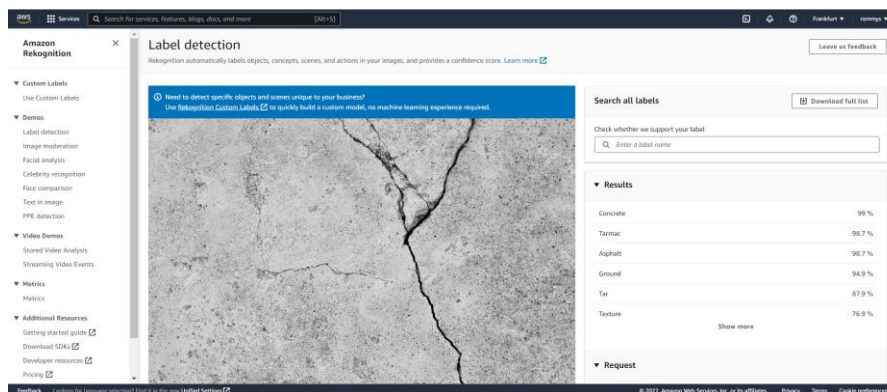
Fig. 2. Label detection of concrete image

Another detection capability is label-based recognition. At that time, the results of the faded labels appear on the right side of the screen. For example, Figure 2 shows a crack in a concrete base.

The result of detecting the main features in the image based on the labels showed quite good results. The most relevant words of the image are found, such as concrete (confidence 99%), tarmac or asphalt (98.7%), ground (94.9%), tar (87.9%), texture (76.9%), and floor (58.7%).

However, there are limits in the tag detection algorithm on the number of words that can be tagged. A search string can be used to find expected tag values, or a file can be downloaded from the tag list. The classified label file contains 2580 words and 258 labels with bounding box words. These data are contained in two CSV (Comma Separated Values) files, respectively, which can be downloaded directly from the web page. This is the result of some words being missing from the list of available defined words. As you can see, in Figure 2 with the detection of cracks in the concrete, the "crack" label is not found.

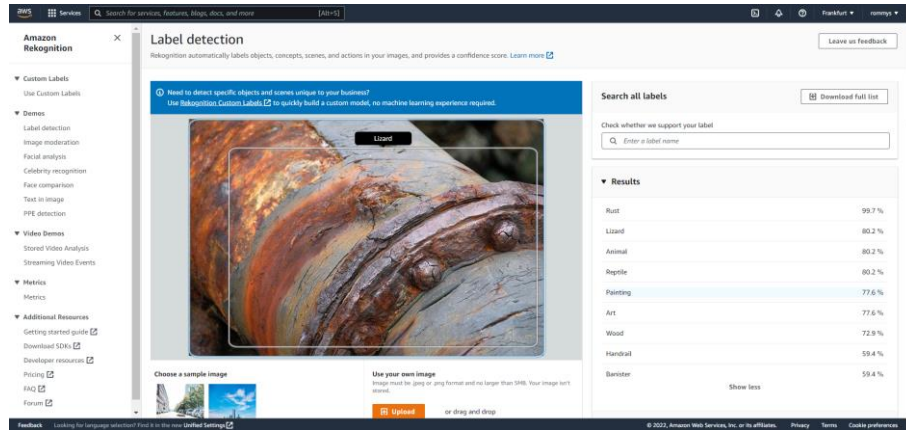
Fig. 4. Label detection of corrosion pipe

For a more detailed examination of the tag detector, an image has been uploaded to AWS with a corrosion pipe. Figure 4 shows that the list of words has been detected and some objects have been highlighted with labels and bounding boxes. As a result, the following labels are detected from the image with a confidence value: rust (99.7%), lizard (80.2%), animal (80.2%), reptile (80.2%), painting (77.6%), art (77.6%), wood (72.9%), handrail (59.4%), and banister (59.4%). Some of these words may not exactly correspond to the image used, but the tag "rust" is shown correctly. The indicated words may be associated with a limited number of labels and image coloring. The image has "Painting" and "Lizard" bounding boxes highlighted. It can be observed from the API response received by JSON that the words reptile and animal are parent words to the word "Lizard". That's probably why these words appear in the list of results.

The next step is to highlight the area where the word "Lizard" is found in Figure 4. In Figure 5 the same area is highlighted with a "Painting" bounding box. In addition, the following labels are found wood (99.2%), rust (94.9%), rock (93.6%), slate (84.4%), painting (55.8%), and art (55.8%).

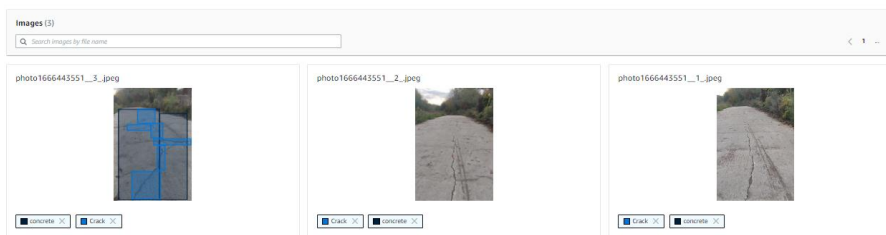
Fig. 8. Applying labels to training images with selected areas of crack and concrete

As shown in Figure 8, a real part of a concrete road with cracks is taken as a test pattern. There are also other elements in the picture, such as bushes and trees, which should not be recognized.

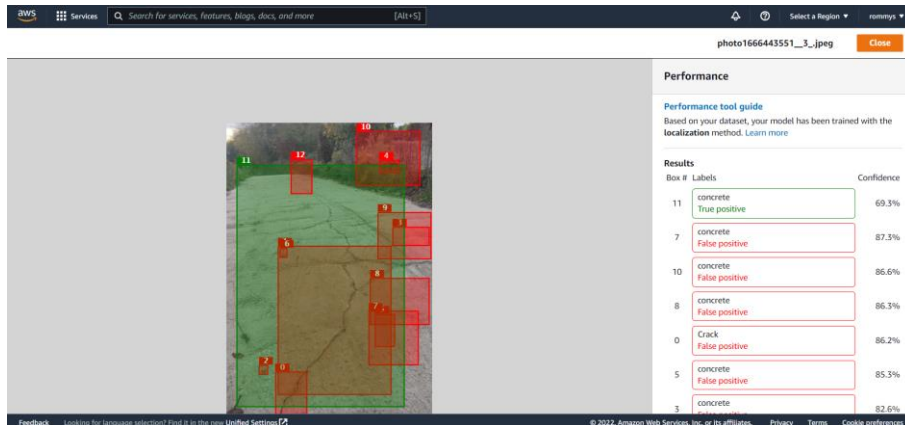
Fig. 12. Detected bounding boxes based on 40 training images

A larger amount of labeled test data is selected for the next run. 19 more images from different angles of cracks from a similar area are added to the 21 test data marked with labels. As can be seen in Figure 12, the concrete is detected, but the cracks are not in all areas and not exactly. In many places, it is expected that the crack mark instead contains concrete.
